# GM Loss and Stability Analyzes on MV. Pacific 88 During The Surabaya Port Accident

**Abstract**— iNews on February 2, 2026 at 04.00 a.m, an accident occurred on the MV. Pacific 88 when it was on the starboard side alongside at Surabaya Port which caused the death of one stevedoring worker. Built in 1992, has a LOA of 88,4m with a LBP of 15,0m and a NT of 1,532 m3. The ship suddenly heels to the starboard side, the cargo on deck shifted and containers fell into the sea. The purpose of this case study is to analyze, understand the causes of ship accidents during loading and unloading from the science of ship stability by calculating the gravity metacentric height-GM value. This case study uses a qualitative descriptive method, processes secondary data, formulates, interprets formulas in numerical values theoretically to provide solutions and analyzes the causes of the KM. Pacific 88 ship accident without answering hypothetical variables. Internal factors such as shifting cargo weight, on deck loads, and ballast-free surface water conditions as well as shifting the 'g' point at the end top of the crane are factors causing the ship to heel due to errors in stability calculations and

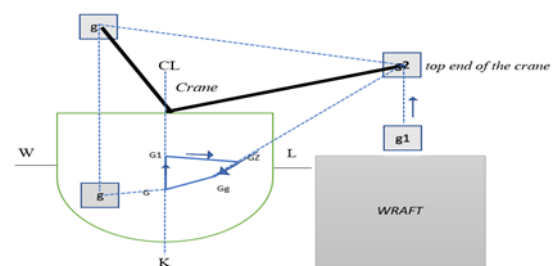
One factor that needs particular attention in this case is the suspended-load effect during crane operation. Once a container is lifted clear of its original support, its weight is considered to act at the crane suspension point. This produces a virtual rise in G and reduces effective GM. When the crane is operated away from the ship's centreline, the suspended load also creates a transverse heeling moment. On a vessel with a limited stability margin, this condition may become more critical when combined with deck-cargo distribution and free surface effects. If seen in the image, point G is located at the center point of the ship's midship line, point G moves upward to G1 and the formulation forms a triangle with a calculated angle of ship tilt. As a result of the movement of point G upwards to G1 as seen in figure 3, this is what

Figure 3. Shifting point g1 to g2 of the end top of the ship's crane

**The second problem analysis** in this respect, the crane operation should be discussed as a suspended-load condition: while a container is suspended, its weight is considered to act at the point of suspension. This may increase the effective vertical position of G and, where the crane operates off the centreline, introduce a heeling moment. In the present case, this mechanism is technically relevant, although it cannot be quantified without the lifted weight and crane outreach at the time of the incident. Darrett & Barrass (2006) in his book explains that when the MV. Pacific 88 ship crane lifts the container load from the pier, the formulation of the point g on the container load will move towards the end point of the crane as seen in Figure 3. If the first analysis of the principle of protecting the ship is not fulfilled, it can be explained that at the time of the incident the GM value of the MV.Pacific 88 ship also shows a decreasing value. If seen from the triangle in figure 3 the shift of point G moves upwards to G1 on the ship's center line meaning that the container load being lifted, especially if it is predicted that the load capacity lifted by the ship's crane exceeds the container load capacity limit (heavy load), the diagonal point g1 automatically moves towards 'g2' at the end of the ship's crane. This illustrates the acceleration of the movement of point G to the condition  $G = M$  with  $GZ = 0$  or the point exceeding point M which is called negative stability or GZ is no longer a supporting arm but a supporting arm. In this condition, because the KM.Pacific 88 ship is in the berthing pool so that the forces acting from outside cannot affect the conditions at the time of the incident, this can be proven that the ship did not capsize but remained in a right-leaning condition.

**Solution to the second problem** in this respect, the crane operation should be discussed as a suspended-load condition: while a container is suspended, its weight is considered to act at the point of suspension. This may increase the effective vertical position of G and, where the crane operates off the centreline, introduce a heeling moment. In the present case, this mechanism is technically relevant, although it cannot be quantified without the lifted weight and crane outreach at the time of the incident. So when the container is about to be loaded, the ship's officer already knows the existing GM value as well as the change in the GM value if the container cargo is to be loaded. By knowing the existing GM value, there will be efforts to prevent the shift in the GM point from shrinking before the container cargo is loaded, by regulating the water ballast. An alternative qualitative approach to overcome the second problem refers to the Regulation of the Minister of Transportation of the Republic of Indonesia Number PM 44 of 2021 concerning Ship Stability, in Article 13 paragraph 2 (g) and (F). The initial metacentric height (GM) is not less than 0.15 m (zero point one five meters), and the weather criteria are in accordance with the provisions of the (International Code on Intact Stability/IS Code) 2008 and its amendments.

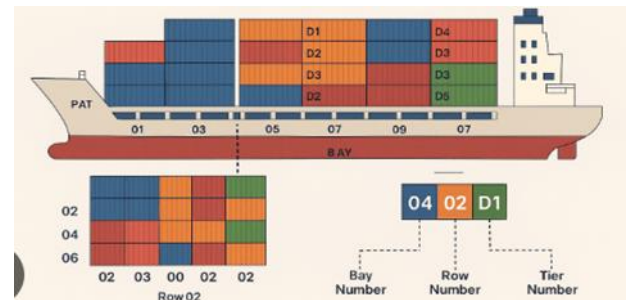
**The first problem analysis** is on the stowage plan-by plan or cargo planning. According to (Istopo, 2003) in the book entitled Kapal dan Muatanya, it is stated in one of the principles that includes 'protecting the ship', it is explained that a merchant ship officer (chief mate) must be able to carry out handling, arrangement and calculation of cargo to maintain the stability of the ship by having the correct final value of the ship's GM.

Figure 4. Stowage Plan-By Plan Container Ship's

**Solution to the first problem** of cargo planning (stowage plan-by plan) is overcome by the ship's officer (first mate) starting the creation of a tentative stowage plan-by plan up to the final stowage plan-by plan document. The contents include information on the name of the ship, voyage, front and rear draft, trim, number of 20ft and 40ft containers, reffer containers, container positions according to tier, row, bay, container code, container weight and capacity of each hold. This final stowage plan document is signed by the first mate and acknowledged by the captain, then this document is distributed to the watch officer and TKBM foreman. This data is supporting data needed in calculating the final GM value of the KM.Pacific 88 ship so that the stability of the ship is maintained and remains seaworthy. In the Indonesian regulatory context, the relevance of container-weight information to stowage planning should be referred to Regulation of the Minister of Transportation of the Republic of Indonesia Number PM 25 of 2022 concerning Container Seaworthiness and Verified Gross Mass, which replaced PM 53 of 2018. This requirement is also aligned with the SOLAS VGM framework, under which verified gross mass must be available to the master or representative and the terminal representative sufficiently in advance for preparation of the ship stowage plan. The Verified Gross Mass (VGM) document or certificate must be signed by the Shipper or Third Party and submitted to the Captain and Port Business Entity or Port Operator and local Harbor Master to be used as a Ship Stowage Plan.

Stowage plan-By plan can be done manually or using applications, currently almost all ships have used applications in making loading calculation plans and the results of the stability information displayed are faster, more detailed and very accurate. The image above is simple information on container loading planning that is similar to the type of ship MV. Pacific 88. This is a recommended solution for making loading plans before loading is carried out on the ship. From there, the information data on ballast water, draft, displacement,

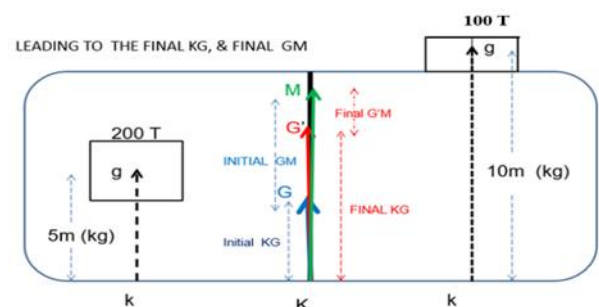
Figure 5. Leading to Final KG & GM

The estimated GM of 1.05 m is higher than the minimum initial GM criterion of 0.15 m stated in the 2008 IS Code. However, the code assesses stability through more than the minimum GM criterion alone; the applicable righting-lever criteria and free surface correction must also be considered. Accordingly, the illustrative GM value in Table 1 cannot by itself demonstrate that the vessel satisfied the required stability condition during the incident. The formula used is Mean Draft = Forward Draft + Aft Draft / 2. If the KM value in the stability booklet table is 8.50 meters, the initial GM of the KM.Pacific 88 can be calculated as follows: Using the assumed KM value of 8.50 m, the estimated GM is calculated as  $GM = KM - KG = 8.50 - 7.45 = 1.05$  meter. The initial GM value of 1.05 meter for the MV.Pacific 88 is explained as follows: According to the International Code of Intact Stability Part A - Mandatory Criteria, 2008, the minimum GMMo, in accordance with the general regulations for cargo ships (General Cargo Ships) in the 2008 IS Code, the initial metacentric height (GMo) must not be less than 0.15 meters. The GM value of 0.15 m is the absolute minimum limit. The detailed criteria of the 2028 International Code of Intact Stability regarding the properties of the stabilizer lever curve are as follows:

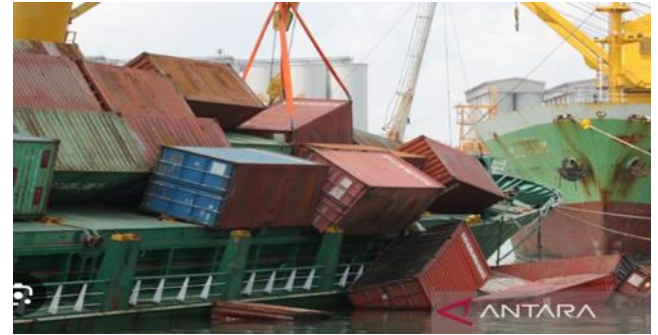
Figure 6. Lashing Container not Installed

While the lashing that was not carried out on the container cargo that resulted in the shift of the container cargo to starboard was not the main factor in this case, more the direct impact of the ship's tilt so that the container cargo shifted to starboard.

**Solution to the fourth problem** is the lashing factor or container fastening is overcome by carrying out port duty officer with full responsibility, meaning always coordinating with the foreman, planner, watch mate and first mate when the lashing can be carried out while still prioritizing the safety of the land crew and the ship's crew who assist in completing the lashing, this is because the work can be done in parts where the hold has been loaded. To be known with the modern system of loading and unloading containers from before the ship arrives, the ship pier and the ship departs neatly arranged on time according to the predetermined schedule. Installation of lashing that does not comply with lashing procedures can cause various problems, such as endangering the safety of the ship, damage to the cargo, or the cargo can fall into the sea. An alternative qualitative approach to overcome the fourth problem is guided by the Shipping Law of the Republic of Indonesia Number 17 of 2008, a seaworthy ship is a condition of a ship that meets the requirements for ship safety, prevention of water pollution from ships, manning, loading lines, loading, crew welfare and passenger health, legal status of the ship, safety management and prevention of pollution from ships and ship security management for sailing in certain waters. Lashing is a condition that is called seaworthy which has an impact on the stability of the ship according to the regulations above.
