# Root Cause Analysis of Compression-bar Failure on Manual Pontoon Hatch Cover Systems

Arwen Surya A. A<sup>1</sup>, Aulia Widyandari<sup>2</sup>, Zulfaidah Ariany<sup>3</sup>, Mohd. Ridwan<sup>4</sup>, Tuti Rachmawati Y<sup>5\*</sup>  
(Received: 11 February 2026 / Revised: 13 February 2026 / Accepted: 19 February 2026 / Available Online: 8 June 2026)

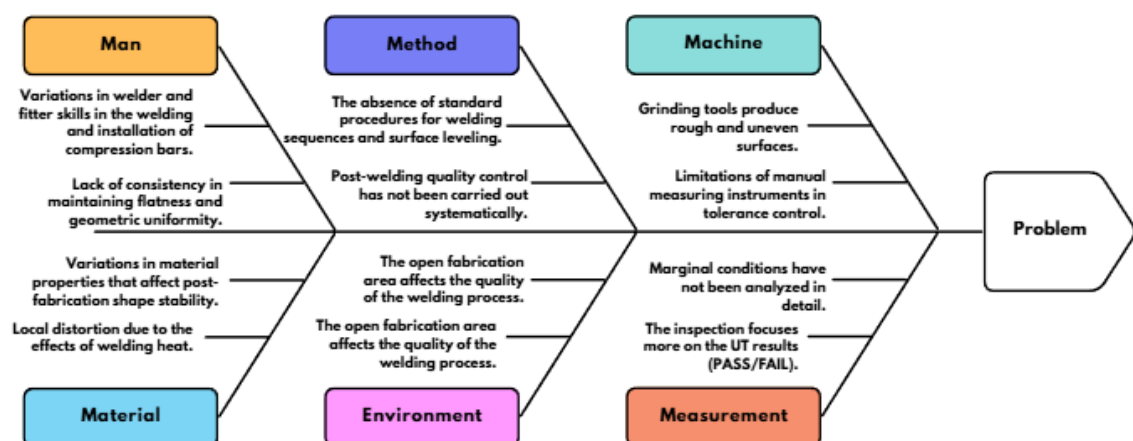
Figure. 1. Fishbone Diagram.

The fishbone analysis indicates that compression bar non-conformities in pontoon-type hatch covers result from a combination of work methods, human skills, and inspection practices rather than a single factor. The absence of standardized procedures and skill variability

leads to inconsistent fabrication, while inspection systems focused on final results fail to detect marginal conditions early, indicating a systemic, process-related issue requiring integrated improvements from fabrication to inspection.
