# Analysis of Oil Leaking from Bowl on The LO Purifier Alfa Laval P626 at MV. SEAPEAK GLASGOW LNGC

**Keywords—** Lubrication Oil Alfa Laval P626, Oil Leaking from Bowl, Fishbone Diagram

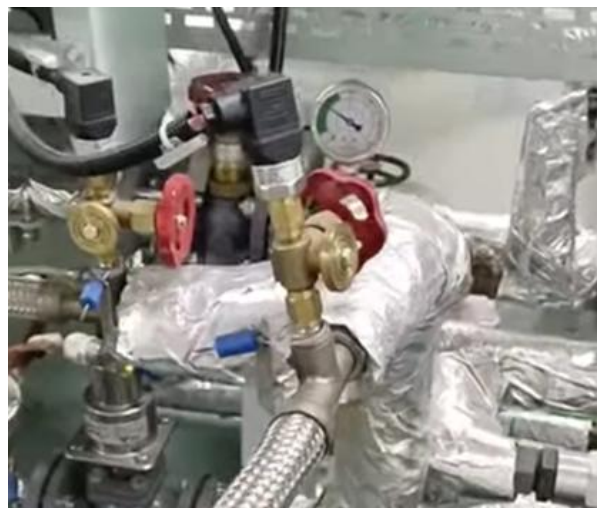
Figure. 1. Low Pressure of PT4

Additionally, an inspection of the water block filter revealed significant scale buildup, causing restricted water flow. During the examination of the inlet and outlet pressure, a drop in outlet pressure (PT4) was also recorded, which ultimately triggered the “oil leaking from bowl” alarm, according to the troubleshooting data presented in Table 4.

Daily logbook entries revealed a significant discrepancy between the normal bowl speed and the speed recorded during the malfunction. Under normal conditions, the bowl should rotate at 12.150 r/min; however, during the incident, the lowest recorded speed dropped to 6.211 r/min, with bowl speed showing fluctuating behavior over the last month. The water block flow rate during the oil leaking incident fell to a minimum of 2 bar, whereas the normal operating range is around 5 bar. Furthermore, the regulating valve pressure (PT4) dropped to as low as 0.1 bar during the trouble event, while it ranges from 1.8 to 2.5 bar under

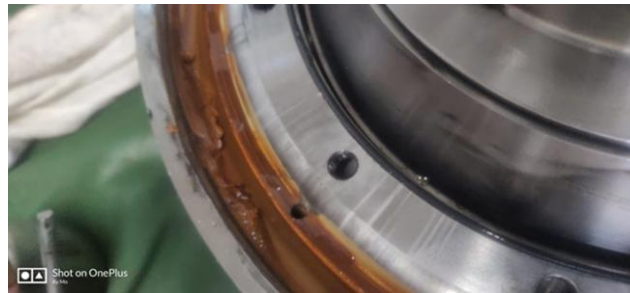
Figure. 2. Scale at Operating Slide

| No | Inspection | Results |
|---|---|---|
| 3. | Inspection of bowl purifier | Scale buildup was found on the discharge slide and operating slide |

The engineer confirmed that the primary cause of the “oil leaking from bowl” issue was the water block filter or solenoid valve blockage due to scale build up, as illustrated in Figures 2 and 3. This obstruction disrupted the formation of the closing water seal, resulting in a

malfunction of the bowl and triggering alarm A57.

To improve the performance of the LO purifier, the 3<sup>rd</sup> engineer carried out maintenance on several components, focusing on the bowl purifier parts. The As water block filter was replaced as part of the corrective measures, and chemical cleaning was conducted using Metal Brite HD Figure 4. This cleaning process was

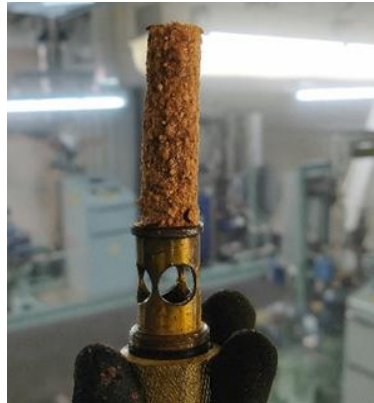
Figure. 3. Scale at Water Block Filter

| No | Inspection | Results |
|---|---|---|
| 4. | Inspection of water block filter | Scale deposits were identified |
