# The Effect of Bima Bay Water Quality Conditions on the Sea Snot Phenomenon

Makbul Hidayat<sup>a</sup>, Feny Arafah<sup>a, \*</sup>, Asryadin<sup>b</sup>, Masrurotul Ajiza<sup>a</sup>

<sup>a</sup>Department of Geodetic Engineering, National Institute of Technology (ITN), Malang, 65145, Indonesia

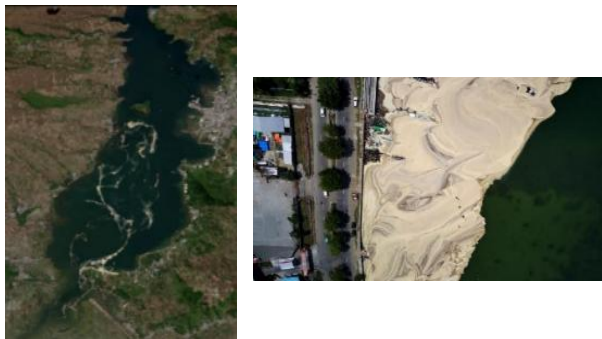
Figure 12. Bima Bay Water Condition in 2022 [19]

Visual imagery is used to conduct an approach based on the recognition of spatial object characteristics. The phenomenon of sea snout that occurs in Bima Bay can be detected from the appearance contained in the Landsat-9 satellite image at the time of the incident. Figure 12 is a visual display of images on April 28, 2022:

Based on the visual appearance of the image, it shows that there is white froth that is quite dense along the coast and in several areas in the middle of the waters of Bima Bay. When viewed from the results of the processing of sea water quality parameters, there are characteristics and patterns that look the same as visual images on the salinity parameter (Figure 8). In areas where there is white foam, it shows a high salinity value as a sign that there has been water pollution in Bima Bay, especially in coastal areas, results in an explosion of algae growth (algae bloom).

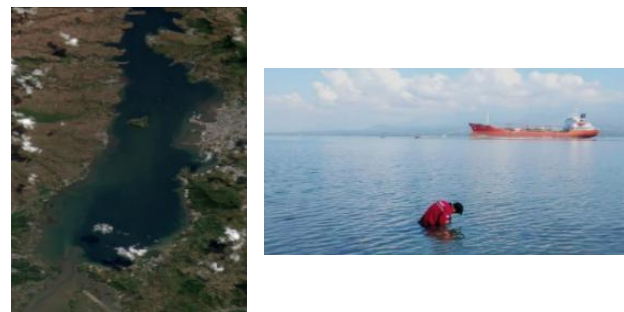
Figure 13. Bima Bay Water Condition in 2023

Figure 13 is a visual display of images and processing results of sea water quality parameters on May 25, 2023, which is 1 year after the sea snout phenomenon occurred:

Based on the visual appearance of the image, the condition of the waters along the coast and the center of the waters in Bima Bay looks normal. When viewed from the results of the processing, the SST value shows normal results, while the DO and salinity values still show that the overall water quality 1 year after the occurrence of the sea snout phenomenon still has a value that is not in accordance with sea water quality standards (Figure 7 and Figure 9). The existence of DO and salinity values in 2023 that are not in accordance with sea water quality standards indicates that there is still pollution in the waters of Bima Bay.
