# Evaluation of Damage and Strengthening Recommendations: A Case Study of the Lontar Badminton Sports Hall

An evaluation and recommendations for strengthening the structure of the Lontar Badminton Sports Hall were conducted to assess its adequacy after damage occurred to the strauss piles and the collapse of the retaining wall. Evaluation methods included an initial survey, destructive and non-destructive testing of structural elements, and structural analysis. Material test results indicated that the compressive strength of the concrete in the upper structure averaged 22.55 MPa. In contrast, the strauss pile structure had an average compressive strength of only 6.81 MPa. This disparity suggests that the concrete quality in the substructure elements is substandard. Analysis of the steel element capacity revealed a maximum cross-sectional capacity ratio of 10.7 for the HCO and CNP profiles. This indicates that certain elements may not be able to support the design load. Additionally, five types of pile caps—PC1, PC1-A, PC2, PC4, and PC5—have been identified as unsafe due to a combination of axial loads and moments that exceed their capacity. Furthermore, the reinforced concrete flo

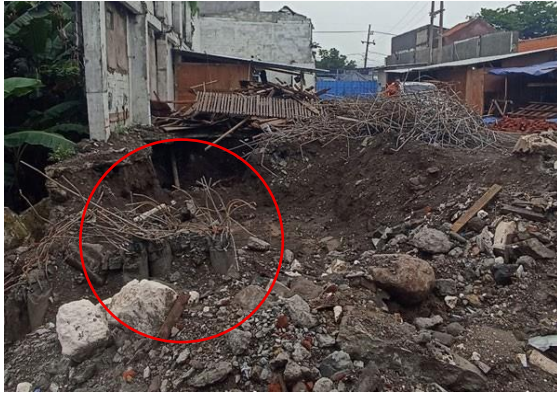
Figure 3 Identification of strauss pile failure

The sports hall is a steel-framed structure. At the time of the damage, the building was still under construction, having reached the stage of rafter installation. The situation was exacerbated by the condition of the strauss pile foundations and the side building's pedestal columns,

specifically at axes 1/G and 1/H, which were already collapsed at the time of the initial survey. In building construction, deep foundations are a critical element in bearing design loads, as they serve to transfer loads from the upper building structure to the ground [9]. To analyse structures accurately, the use of software such as SAP2000 has become standard practice in structural engineering for modelling and calculating structural responses to various load combinations [10], [11] as demonstrated in various building structural evaluation studies [12], [13].

technical standard specifications. This poor concrete quality resulted in the strauss pile foundations being unable to bear the axial load and moment from the superstructure, as evidenced by the physical finding of a fractured foundation as shown in Figure 3 and Figure 4. Furthermore, the configuration of the existing pile cap was unable to provide sufficient bearing capacity for the applied loads, causing the stresses to exceed the allowable soil capacity. A summary of the calculation results for the lower structure's capacity can be seen in Table 10.

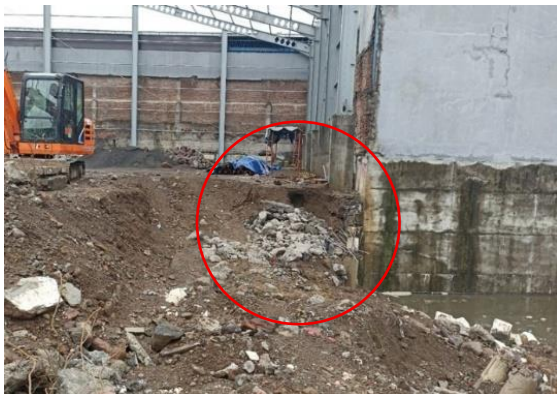
Figure 4 Identification of retaining wall failure

In practice, events such as uneven ground settlement, soil pressure due to poor drainage, or inadequate material quality can cause fatal damage [4]. This damage often progresses over time. This situation occurred in the Lontar Badminton Sports Hall Construction Project. Based on the results of an initial survey of the existing building's condition, structural damage was identified, including damage to the strauss piles and the collapse of the retaining

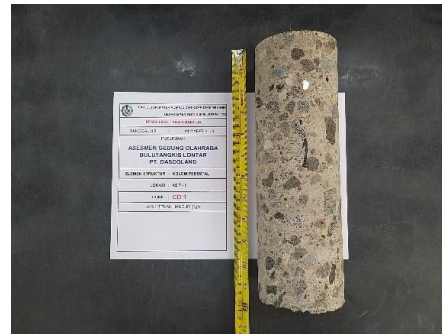
Figure 5 Core drill test specimen CD-1: (a) side view and (b) top view

Prior to conducting the compressive strength test, the concrete core drill samples are measured and their surface condition examined. The measurements and surface condition of the concrete core drill samples are recorded on the core log sheet. From these records, the number and position of the reinforcing bars remaining within the concrete core drill samples are identified; this information is subsequently used to determine the conversion of the concrete sample's compressive strength due to the remaining reinforcing bars. Figure 5 shows an example of a test specimen and the process of conducting the

compressive strength test on a concrete core drill cylinder sample at point 1 on the pedestal column.

The results of the core drill test can be seen in Table 1 and Table 2. The average compressive strength of concrete for the upper structure is 22.55 MPa. In contrast, the average compressive strength for the lower structure, specifically the strauss piles, is 6.81 MPa.

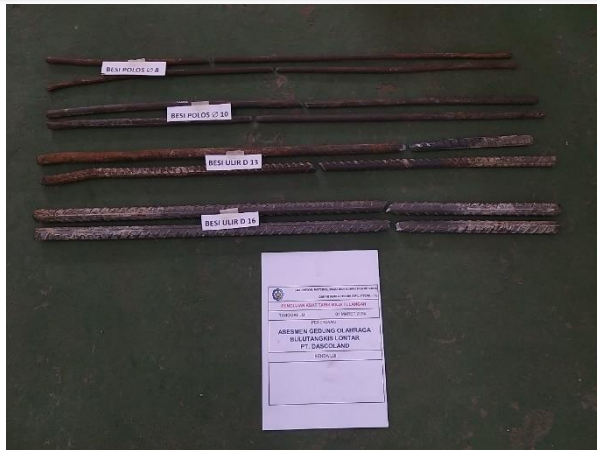
Figure 7 Reinforcement tensile test specimen

This test was conducted to determine the yield strength ( $f_y$ ), tensile strength ( $f_u$ ) and ultimate strain of the reinforcing steel. A total of 8 (eight) samples were taken for this test. Based on the results of the tensile strength test of the reinforcing steel, it was found that the plain concrete bars Ø8 mm and Ø10 mm fall into the BJTP 280 classification and the D16 threaded concrete bars into the BJTS 420 classification. Meanwhile, the D13 threaded concrete bars fall into the BJTS 280 classification. The test results for the tensile strength of reinforcing steel are shown in Figure 7 and Table 4.
