# Evaluation of Subgrade Bearing Capacity (CBR) And Subsurface Layer On Treated Subgrade Using Grouting Water Cement In The Tuban-Babat-Lamongan-Gresik National Road

One of the causes of the damage that occurred on the Tuban–Babat–Lamongan–Gresik national road is the subgrade condition which has a low CBR value. From the results of the soil investigation, the CBR value is less than 3.0%. To evaluate soil bearing capacity (CBR) and the condition of the subsurface layer after grouting, laboratory and field scale tests were carried out. Laboratory testing by modeling CBR test objects according to field density with injection variations in the quantity of grouting material and water-to-cement ratio (w/c). Variations in the quantity of grouting material injected were 3%, 5%, and 7% of the dry unit weight of the soil samples tested with variations in the ratio of water-to-cement w/c=1, w/c=1.5, and w/c=2. While field testing is carried out by acquiring Ground Penetrating Radar (GPR). The greatest increase in the CBR value occurred in variations in the injection quantity of grouting material at 7% and w/c=1. In the soil sample Sta 37+850 the initial CBR value of 1.41% increased to 2.47%,

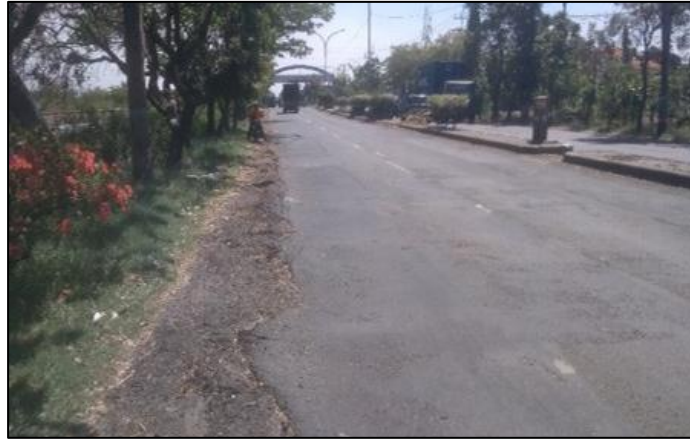
**Figure 1.** Road Damage On The Tuban–Babat–Lamongan–Gresik Road Section  
source: BBPJJN East Java-Bali, 2021

From **Figure 1** above can be seen that the damage that occurs on the asphalt pavement surface, some of the possible causes of damage are high daily traffic (LHR), passing vehicles with dimensions and overload (ODOL), problematic and soft soil conditions. In addition, road damage is also caused by subgrade conditions that have low CBR values. From the results of soil investigations using the DCP test, the CBR values are obtained as shown in Table 1.

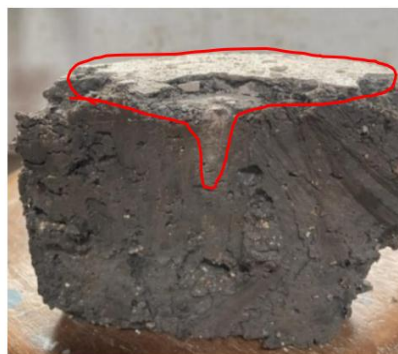
**Figure 5.** A layer of cement paste on the surface of the soil sample at Sta.37+850  
source: Author's Data, 2022

From **Figure 5** above it can be seen that the cement water injected into the soil sample of the test object does not enter and spreads into the soil layer so as to form a paste layer on

the top surface of the test object. So that the increase in the CBR value that occurs during CBR testing is due to the paste layer on the surface of the test object becoming hard, not due to increased soil density. The strength of the CBR value is also influenced by the location of the grouting point on the CBR sample where the grouting point on the sample is right in the middle and the piston penetration of the CBR laboratory test equipment also hits the middle of the sample surface so that it greatly influences the increase in the resulting CBR value. In addition, the resulting CBR value also depends on the density of the soil on the specimen. The higher the soil density, the higher the CBR value will be. This is due to the nature of cement which absorbs water and the smooth texture of cement so that it can fill the pores of clay soil thereby increasing the unit weight of the soil which automatically increases soil strength.
