# Assessment Study of Drying Process Effect on Soil Cracks of Un-Treated and Lime Treated Bobonaro Clay

Soil cracks and landslides are indeed major geotechnical challenges in the eastern sector of the Republic of Indonesia–Democratic Republic of Timor-Leste border section. When there is a change in weather from the rainy season to summer, cracks will appear on the Bobonaro clay, besides that there will be changes in the values of the physical and mechanical parameters of Bobonaro clay when exposed to weather. This research focused on crack behavior and analysis of changes in physical and mechanical properties due to the drying process. Laboratory tests will be carried out on 3 samples, namely initial soil conditions, compacted conditions, and soils treated using  $\text{Ca(OH)}_2$  lime conditions. analysis of crack calculations or Crack Intensity Factor (CIF) values is carried out using matlab 2019a software. The value of the crack intensity factor (CIF) for the initial soil conditions at the end of the drying process was 2.5755% where there were cracks since the beginning of the drying process with crack patterns occurring in almost the entire sample from the edges to the middle

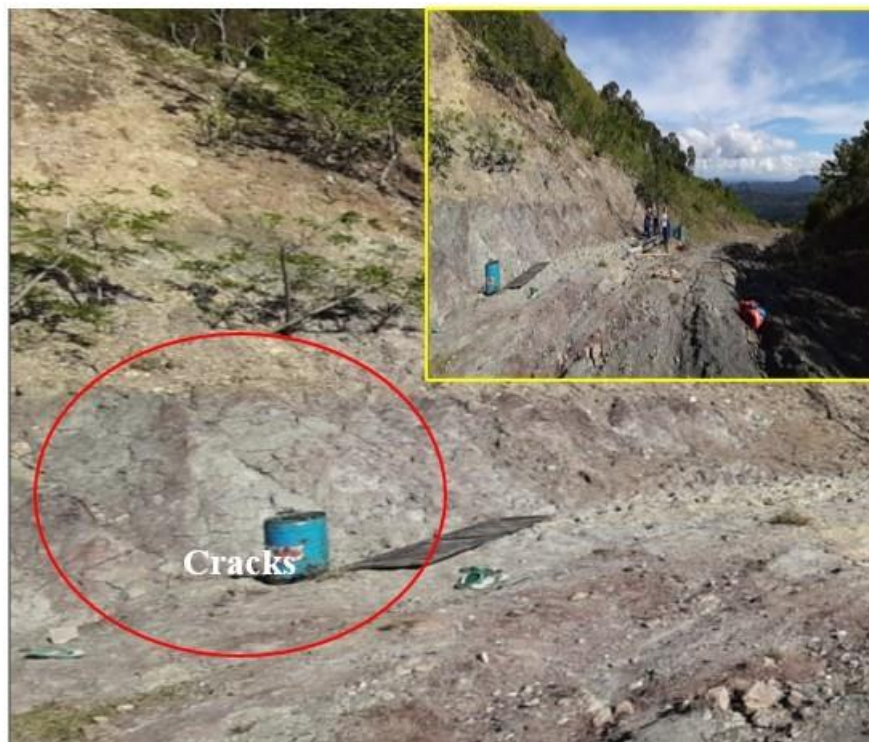
Bobonaro clay on the Motoain-Henes-Motomasin National Road Section has special characteristics, Changes in physical parameters and mechanical parameters of Bobonaro clay only occur when exposed to weather and cause many cracks as shown in Figure 2. This is also supported by test data that has been carried out by the planning and supervision unit of East Nusa Tenggara province, BPJN East Nusa Tenggara.

**Figure 2.** Sta 149+140 Motoain-Henes-Motomasin National Road (Site Doc, 2022)
