# Study Of Road Stability On The Side Of The Konaweha River, Kab. Konawe, Southeast Sulawesi (Km 29+300 S/D Km 29+800) Due To The Combination Of The Effect Of River And Traffic Load)

Galih Anom Windardi<sup>1,a)</sup>, Indrasurya Budisatria Mochtar<sup>2,b)</sup> & Freddy Siagian<sup>3,c)</sup>

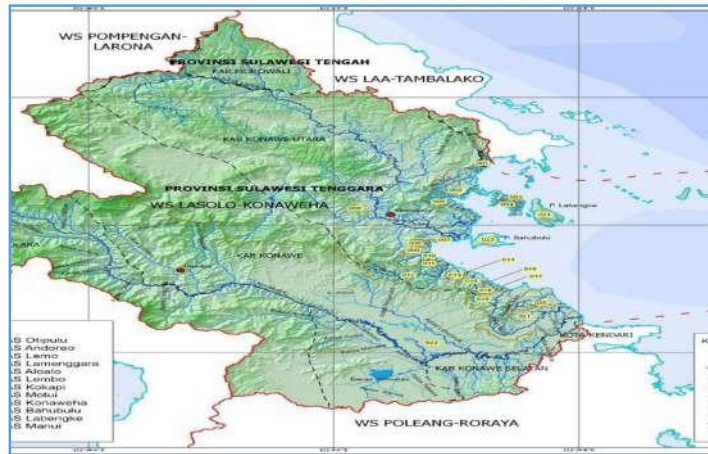
**Figure 1.** Lasolo – Konaweha River Area

The Konaweha River is one of the main watersheds of the Lasolo-Konaweha river area which is under the authority of BWS Sulawesi IV Kendari. The area of the Konaweha watershed as a whole is 6,487.2 km<sup>2</sup> with a river length of 327.22 km. On the peak flood discharge of the Konaweha river for a period of 25 years and 50 years, the water overflowed into the road as high as 0.41 m and 1.12 m.

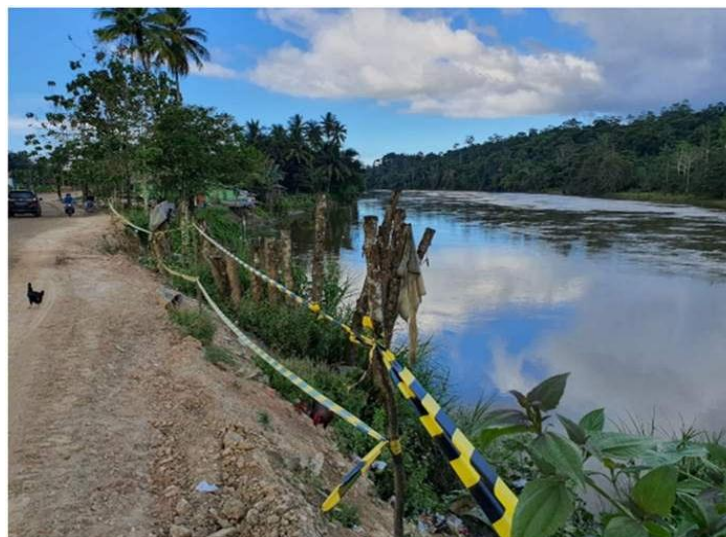
In 2020, a landslide occurred along the road section connecting North Konawe/Konawe Regency to Pohara, between Km 29+300 and Km 29+800. The most severe damage took place at Km 29+800, where nearly half of the roadway became inaccessible to vehicles. Temporary repair efforts were made by installing a makeshift retaining structure using wooden stakes

**Figure 2.** Temporary repairs of the landslides by placing a recess made of wooden stakes  
This section is a vital segment because there are mining and processing of nickel ore.
