# Condition and Durability Evaluation of Reinforced-Concrete Bridge Girders in the Surabaya Container Terminal Environment

An access bridge at PT Terminal Petikemas Surabaya has operated since 1992 in a chloride-bearing marine environment and carries repetitive heavy operational vehicles. The reinforced-concrete girders were repaired by epoxy injection and strengthened with carbon-fibre-reinforced polymer between 2010 and 2014; however, cracks were identified again in 2021. This study evaluates the existing condition and durability of the girders by integrating repair-history review, visual inspection and crack mapping, concrete core testing, rebound-hammer testing, reinforcement detection, half-cell potential measurements, and chloride-based service-life analysis. Seven 93-mm-diameter cores produced equivalent standard-cylinder compressive strengths of 51.33–59.31 MPa, with a mean of 54.74 MPa and a coefficient of variation of 5.20%, while the average rebound-hammer estimate was 62.02 MPa. A representative girder cover of 60 mm was adopted for durability modelling, although the raw scans contained local readings from 20.4 to 68.7 mm. Across ten girder half-cell survey areas, indi

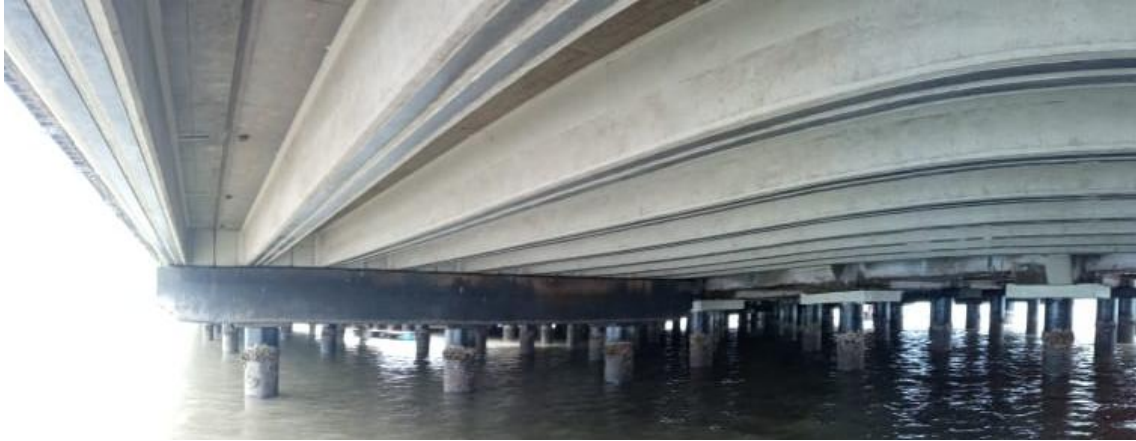
Figure 1. Access bridge at PT Terminal Petikemas Surabaya.

The access bridge investigated in this study was built in 1989 and has operated at PT Terminal Petikemas Surabaya since 1992. Between 2010 and 2014, cracks were repaired by epoxy injection and selected girders were strengthened with CFRP. Cracks were identified again in 2021 and were re-injected. The structure is located in a marine terminal and carries trucks, dollies and heavy container-handling equipment whose configurations have evolved since the original design. This history makes the bridge a relevant case for integrated condition and durability assessment.
