# GM Loss and Stability Analyzes on MV. Pacific 88 During The Surabaya Port Accident

**Abstract**— iNews on February 2, 2026 at 04.00 a.m, an accident occurred on the MV. Pacific 88 when it was on the starboard side alongside at Surabaya Port which caused the death of one stevedoring worker. Built in 1992, has a LOA of 88,4m with a LBP of 15,0m and a NT of 1,532 m3. The ship suddenly heels to the starboard side, the cargo on deck shifted and containers fell into the sea. The purpose of this case study is to analyze, understand the causes of ship accidents during loading and unloading from the science of ship stability by calculating the gravity metacentric height-GM value. This case study uses a qualitative descriptive method, processes secondary data, formulates, interprets formulas in numerical values theoretically to provide solutions and analyzes the causes of the KM. Pacific 88 ship accident without answering hypothetical variables. Internal factors such as shifting cargo weight, on deck loads, and ballast-free surface water conditions as well as shifting the 'g' point at the end top of the crane are factors causing the ship to heel due to errors in stability calculations and

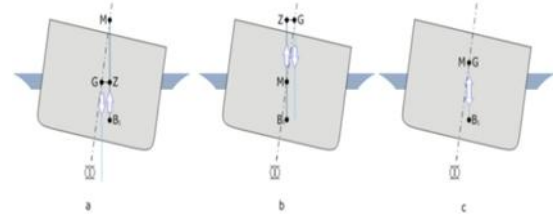
Figure 1. Positive, Negative & Neutral Stability

1. The explain the ship's virtual points operating under positive, negative, and neutral stability, which relate to the final GM formula obtained during the loading and unloading process. There is a force acting both downward and upward, in this case study focusing on the ship's tilted position, the uprighting arm  $GZ = 0$ . If it reaches point M beyond point M or  $GZ = \text{negative } (-)$ , the uprighting arm is no longer the uprighting arm but

becomes a forward arm, as formulated in Figure 1. The estimated GM was interpreted in relation to initial transverse stability. A positive GM indicates an initial restoring tendency, while a reduced GM indicates a lower stability margin. This interpretation was applied to the reconstructed scenario and not presented as the vessel's verified stability condition during the incident.

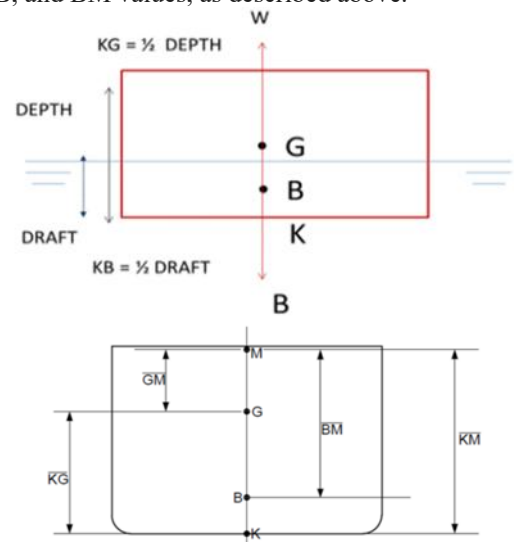
Figure 2. Low of Flotation

The buoyancy formula in Figure 2 explains that the downward pressure is depicted by point G and the fulcrum of the upward pressure is depicted by point B (buoyancy). Therefore, to calculate the GM value, the formula  $GM = KM - KB$  can be used. In the stability booklet-static curve table, by looking at the average draft of KM and KB values, the formula  $KB = \frac{1}{2} \times \text{draft}$  is more general and practical. Rachman et al. (2014) entitled Identification of Ship Transverse Stability Lines Through Tilting Experiments Using Arduino-Based Delphi. The journal explains that the precision value depends on the block coefficient and the actual transverse shape of the ship's stern (rectangular plate, V-shaped, and U-shaped). Meanwhile, the formulation of the  $KM = KB - BM$  value is explained by KB (height of buoyancy from the keel).

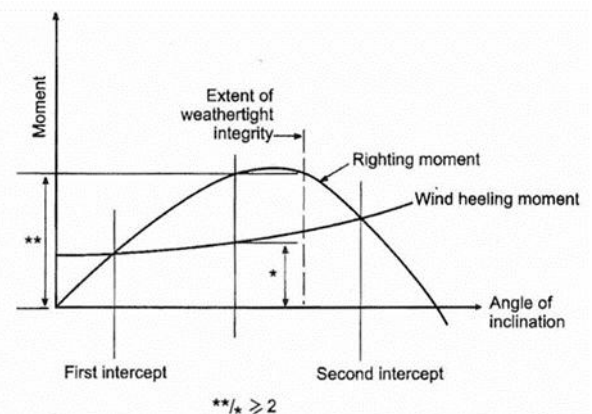
Figure 5. Righting Moment and Wind Heeling Moment Curves

The estimated GM of 1.05 m is higher than the minimum initial GM criterion of 0.15 m stated in the 2008 IS Code. However, the code assesses stability through more than the minimum GM criterion alone; the applicable righting-lever criteria and free surface correction must also be considered. Accordingly, the illustrative GM value in Table 1 cannot by itself demonstrate that the vessel satisfied the required stability condition during the incident. The formula used is Mean Draft = Forward Draft + Aft Draft / 2. If the KM value in the stability booklet table is 8.50 meters, the initial GM of the KM.Pacific 88 can be calculated as follows: Using the assumed KM value of 8.50 m, the estimated GM is calculated as  $GM = KM - KG = 8.50 - 7.45 = 1.05$  meter. The initial GM value of 1.05 meter for the MV.Pacific 88 is explained as follows: According to the International Code of Intact Stability Part A - Mandatory Criteria, 2008, the minimum GMMo, in accordance with the general regulations for cargo ships (General Cargo Ships) in the 2008 IS Code, the initial metacentric height (GMo) must not be less than 0.15 meters. The GM value of 0.15 m is the absolute minimum limit. The detailed criteria of the 2028 International Code of Intact Stability regarding the properties of the stabilizer lever curve are as follows:

In actual operation, container ships often require significantly higher GM values to meet the GZ curve area criteria, especially under full load conditions. Historically, the MV. Pacific 88 was known as a general cargo ship and was later converted to a container ship after meeting the requirements for its class. This calculated GM represents an illustrative reconstructed scenario and should not be interpreted as the verified stability condition of MV. Pacific 88 at the time of the incident. To make it easier to understand, see the image below.

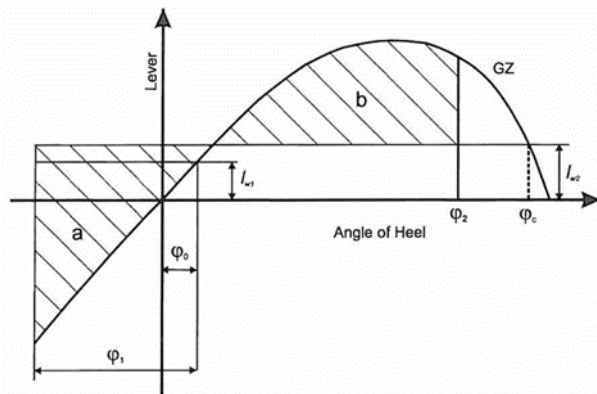
Figure 6. Severe Wind and Rolling

1. The ship is subjected to a steady wind pressure acting perpendicular to the ship's centreline which results in a steady wind heeling lever ( $lw1$ ).
2. From the resultant angle of equilibrium ( $\varphi0$ ), the ship is assumed to roll owing to wave action to an angle of roll ( $\varphi1$ ) to windward. The angle of heel under action of steady wind ( $\varphi0$ ) should not exceed  $16^\circ$  or 80% of the angle of deck edge immersion, whichever is less.
3. The ship is then subjected to a gust wind pressure which results in a gust wind heeling lever ( $lw2$ ).
4. And under these circumstances, area b shall be equal to or greater than area a, as indicated in figure 2.3.1 below:
