## ELDERLY BEHAVIOR SETTING TO RESPONDING ERUPTION DISASTER AT THE TRESNA WERDHA SOCIAL SERVICE CENTER, PAKEMBINANGUN

Adimas Kristiadi\*, Stefani Natalia Sabatini\*

\*) Department of Architecture, Faculty of Architecture and Design, Universitas Kristen Duta Wacana, Indonesia

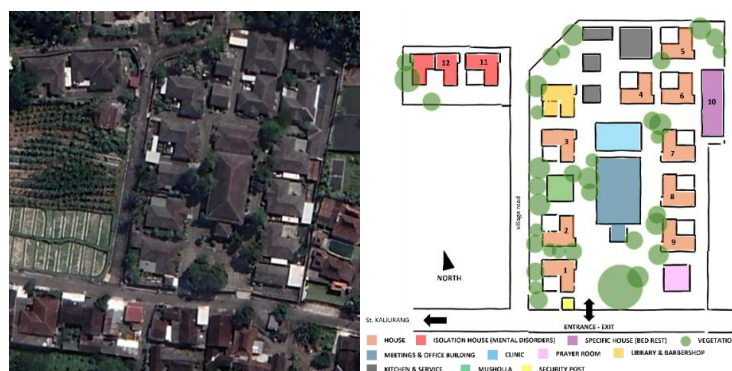
**Figure 3.** Area and building mass order illustration of BPSTW

BPSTW has 12 guest houses that are used as housing for the elderly, as shown in Figure 3. The 12 guest houses have differences that are divided based on their designation. Guest houses number 1 and 2 are paid for which are specifically for the elderly who have their own wishes or their families live in BPSTW. Then the other 8 guest houses are number 3, 4, 5, 6, 7, 8, and 9 are non-paid used as an independent/normal residence for the elderly. While 1 guest house number 10 is a non-paid devoted to the elderly who in their activities need to be assisted by a nurse (bed rest). Meanwhile, there are guest houses that are separated by village road, namely guest houses number 11 and 12, not paid for and used as an isolation, specifically for the elderly who have mental disorders.

The mass order of buildings in BPSTW tends to be symmetrical with the vital space as the center of activity. The residence for the elderly is located on the side and back around the meeting house, management office and clinic. At the entrance of the meeting hall there is a field that is used as a parking area for guest/public vehicles and outdoor activities. The main circulation (road) in the land is in the form of a letter U with an advance on the guesthouse building leading to the road. The average distance between buildings is 5-10 meters.

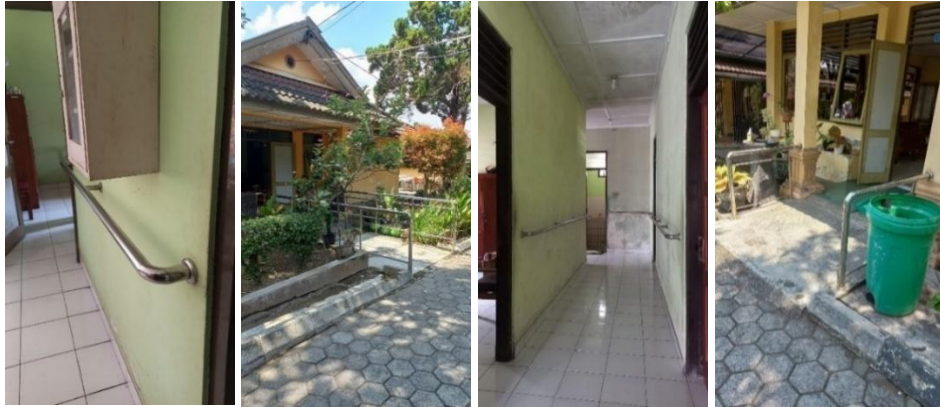
**Figure 5.** Hand railing and ramp in the BPSTW

BPSTW has prepared several facilities that respond to the activities of the elderly, hand railing and ramp. Hand railing has been applied outside and inside the guesthouse. Its position is attached along the wall as a handle for the elderly when

moving, the material is from stainless steel and not slippery. Ramps are located at several points, especially on the terrace of the guesthouse, as a feature that makes it easier for the elderly to carry out activities from places that have elevation differences (Figure 5).

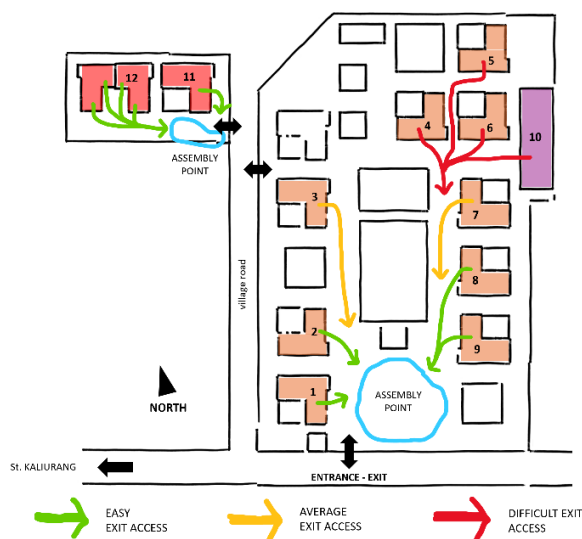
**Figure 7.** Illustration of exit access from the mass layout of BPSTW

Figure 7 explains that the guest house located in front will be easier to get access to open space that functions as a gathering point. Guest houses 1, 2, 8, and 9 have an easy exit with a distance from the door of the guest house to the open space of approximately 20-40 meters. While guest houses number 3 and 7 have a difficult exit, this is because the distance from the door of the guest house to the open space is more than 60 meters. The guest houses 4, 5, 6, and 10 have a very difficult exit. In addition to the distance from the door of the guest house to the open space of more than 80 meters and the farthest is about 105 meters, access to the guest houses 5, 6, and 10 have a winding circulation. The most difficult access is in guest house number 10 because the elderly residents in the guest house are the elderly whose activities must be fully assisted by nurses/guards. In the event of a disaster situation, the elderly in number 10 must be carried or moved with a transportable bed.

Guest houses numbers 11 and 12 are in a smaller area, which is across the street to the west of the large area. The guesthouse is used as a residence for the elderly who have mental disorders. The numbers 11 and 12 are separated because they have different management policies and treatments, it has an easy exit with a distance to the open space of less than 20 meters.

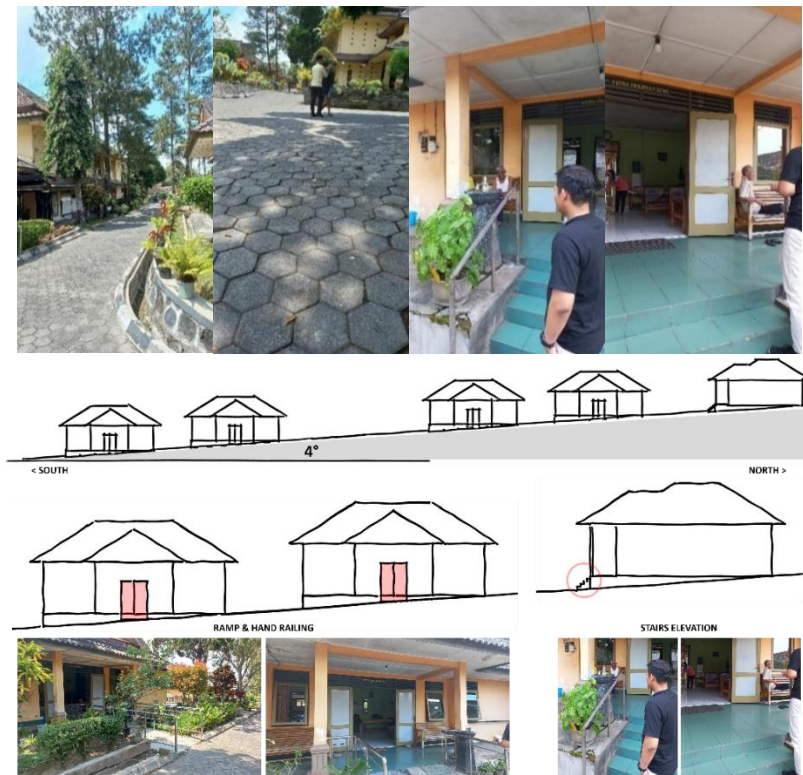
**Figure 8.** The ground level is getting higher to the rear and access stairs at guest houses

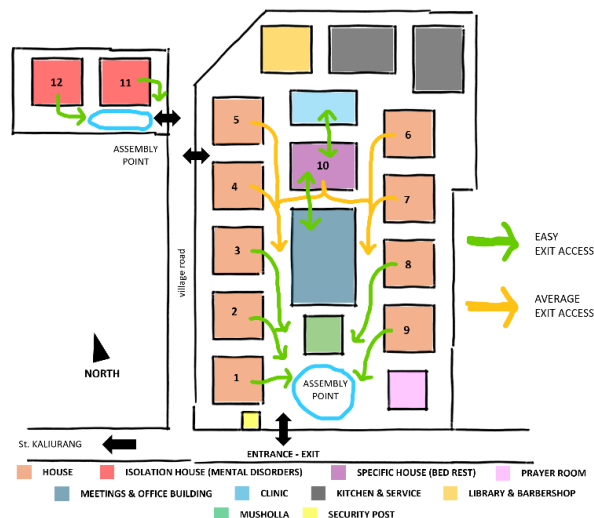
**Figure 9.** Recommendations for the mass layout of buildings in BPSTW

In principle, the recommendations made are still following the size of the BPSTW land area, while the size of the guesthouse is also still following the existing size (Figure 9). Recommendations related to the distance and orientation of the access to the exit of the guest house with an assembly point are realized by placing the guest house on the sides of the edge of the land with the orientation of the access to the exit leading to the center of the land. The exit is directly connected to the main circulation line in the land, which directly leads to the gathering point in the open land in front. Indeed, the distance is not entirely the same between one guesthouse and another, but it is certain that the circulation path is not blocked by anything.

Recommendations related to the distance and orientation of access in/out of the guest house to the management office and other guest houses are related to guest houses that are specifically for the elderly who are bed rest (have total physical limitations). The guesthouse should receive special attention in terms of monitoring and handling from the manager and other elderly people. Bed rest guesthouse is recommended to be in the center between the management office and the clinic, to get maximum monitoring and handling (high accessibility and visibility). This is illustrated by the direction/flow of the green arrow which means having easy access.
